## VIBRATION MONITORING AND FAULT DIAGNOSIS OF AN I.D.FAN AT A CEMENT PLANT

I.D.fan (Kiln) of a Cement plant consisting of a motor, two mechanical couplings, a hydraulic coupling and a heavy fan (approx. two tons) was giving high vibrations at some locations. This was monitored at all the bearing locations and its vibration symptoms were recorded for analysis purpose. Frequency domain and phase analysis were made to diagnose the root cause of vibrations. On the basis of this analysis, fault observed was mainly with the fluid coupling. The vibration spectra and phase data are presented in this paper.

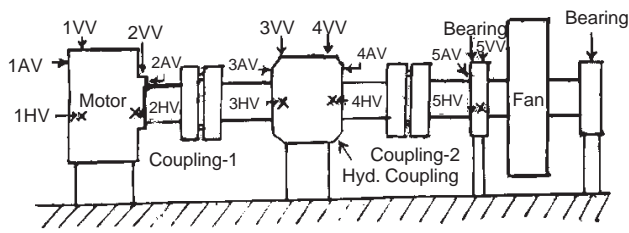
Fig 1. I.D.Fan (Kiln)

The induced draught (I.D.) fan of the Cement plant is shown in Fig 1. The points 1,2,3,4,5 are the bearing locations, where the vibration data were collected in different directions, vertical, horizontal and axial with the help of a data collector. The whole system consists of a motor, two mechanical couplings a hydraulic coupling and a big fan.

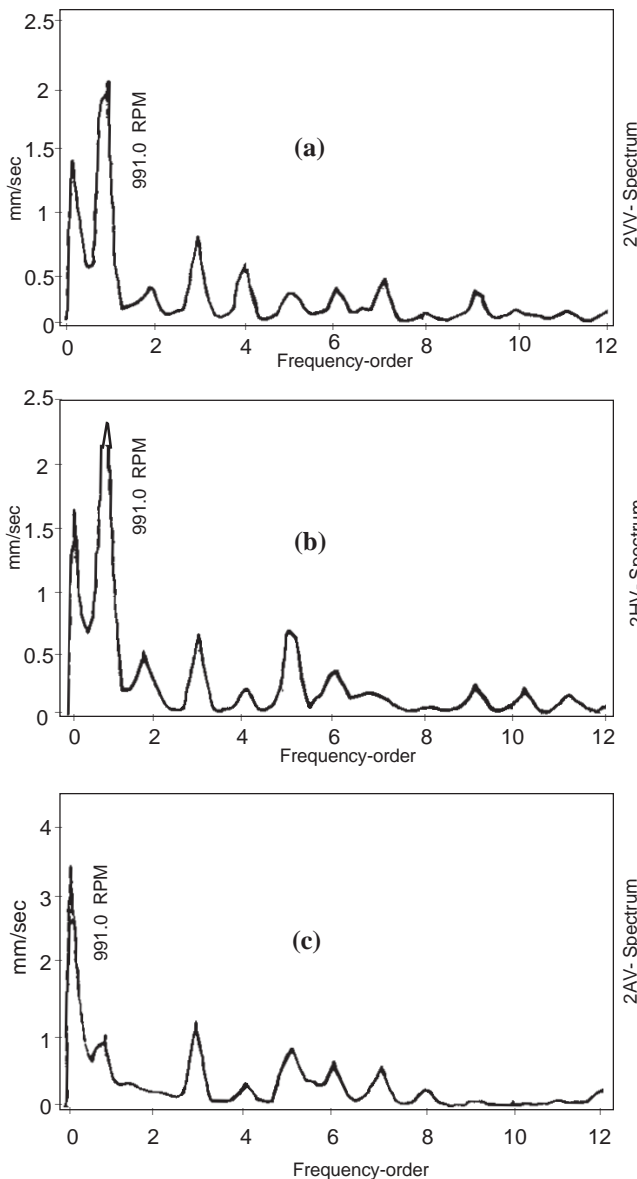
Fig 2 (a,b,c). Frequency domain spectrums at point 2 of I.D. fan.

The high 1X peaks level along with 2X peaks in radial direction across the points 2 and 3 (Fig 2 and 3) is the indication of parallel misalignment in rigid coupling 1.

Any loose mechanical component or foundation is to be checked and rectified. The rigid and hydraulic couplings require adequate rectification. The machine foundation and vibration isolators are also to be checked.

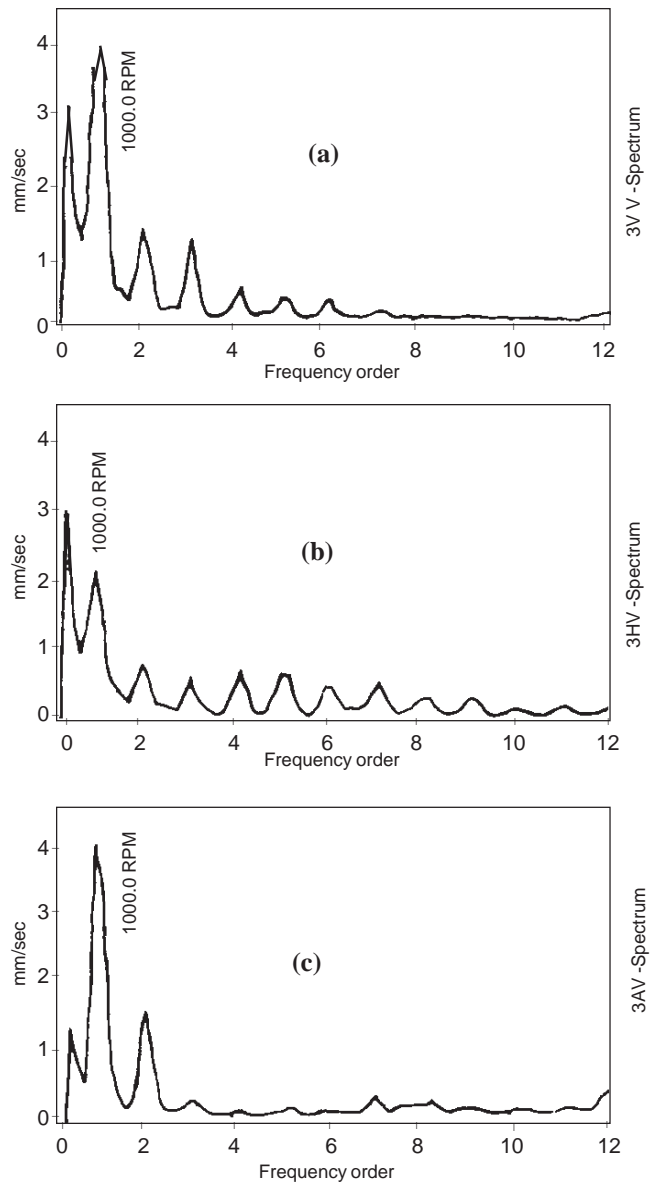
Fig 3 (a,b,c). Frequency domain spectrums at point 3 of I.D.fan.

The high 1X peaks along with 2X peaks in the radial as well as in axial direction across the flexible coupling at point 3 and 4 (Fig 3 and 4) is an indication of misaligned, worn, ceased or locked coupling.

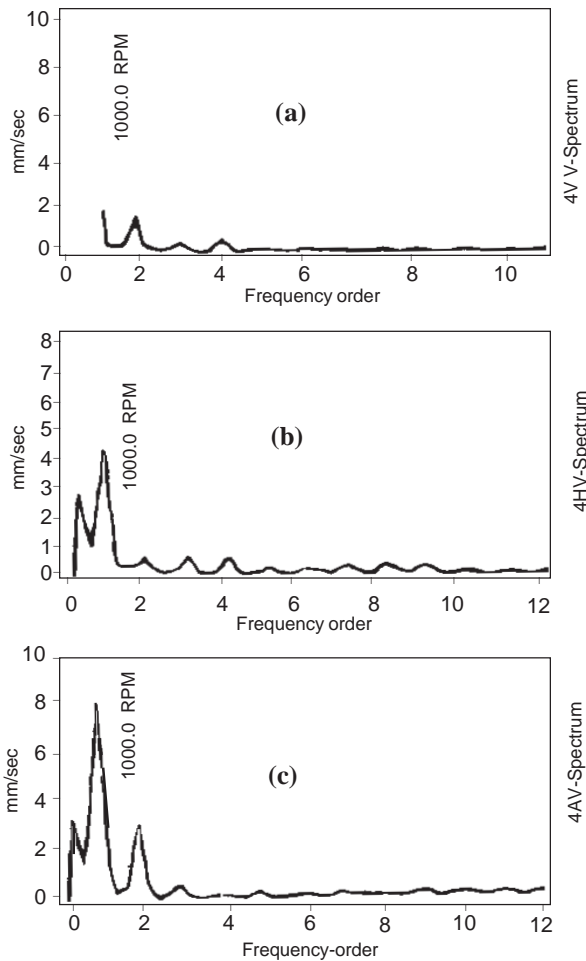
Fig 4 (a,b,c). Frequency domain spectrums at point 4 of I.D.fan.

The high 1X peaks along with 2X peaks in the radial as well as in axial direction across the points 4 and 5 (Fig 4 and 5) is indication of both parallel & angular misalignment in rigid coupling-2
